## Final Report

Preliminary geologic investigation of potential landslides  
in the vicinity of the southern Forest Service gate on the Ridge Route  
in northern Los Angeles County, California

Michael F. Ballard, Geologist

Prepared For  
Ridge Route Preservation Organization  
June 2019

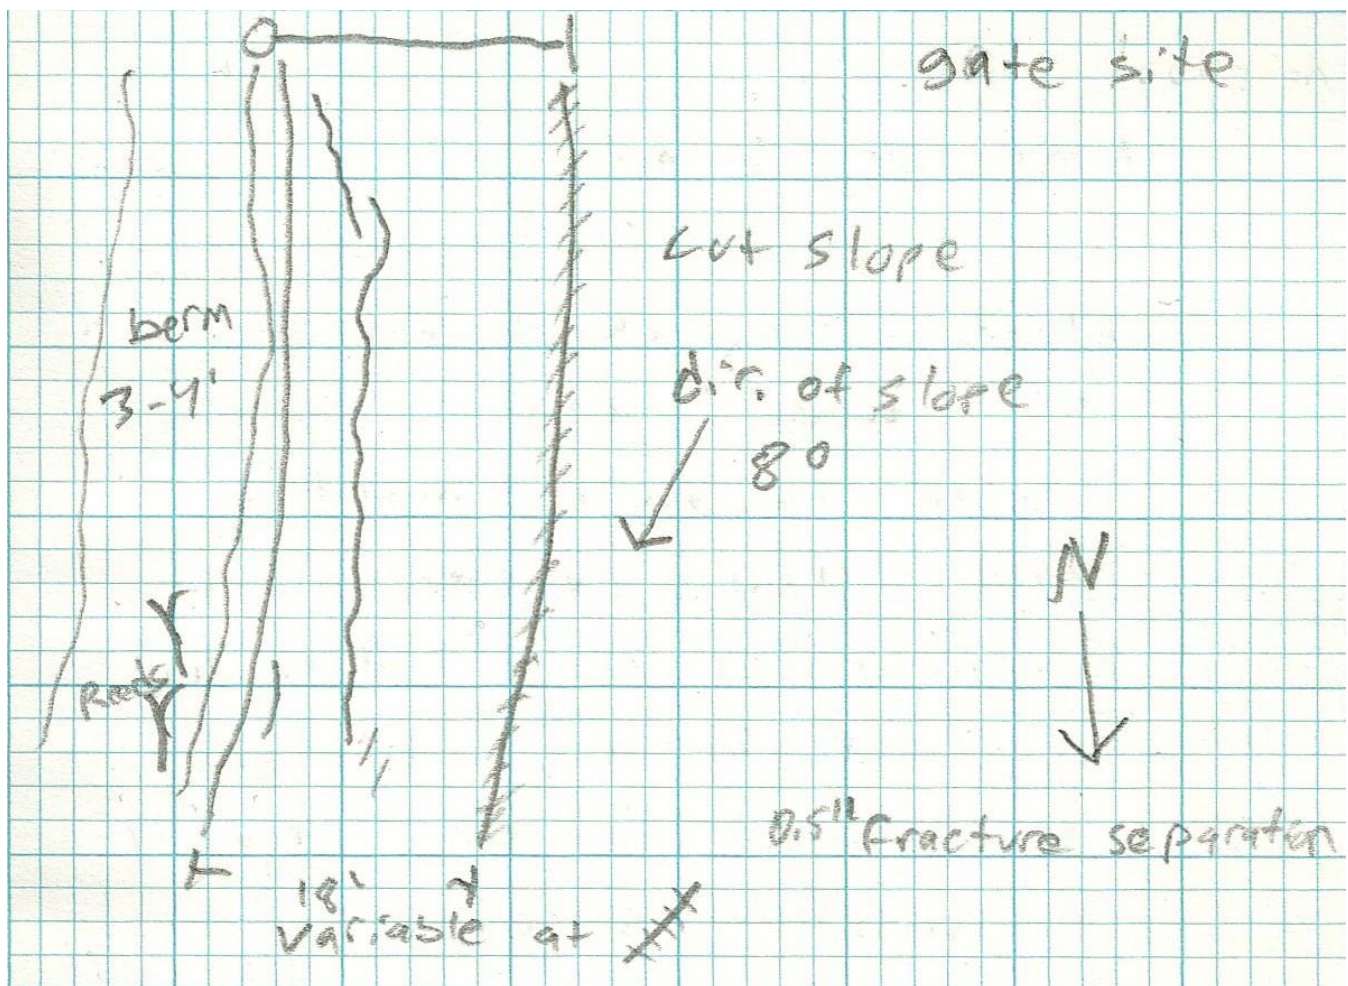
Cracking was found along the southbound, or down slope, side of the roadway. These cracks were approximately 58 feet long and averaged 2.9' from the edge of the 2010 AC overlay. The cracks ranged from about 1.5' to the edge at the south end to 3.9' to the edge at the north end. The cracks exhibited approximately 0.5" of separation and less than 0.5" of subsidence on the east side. Some en-echelon fracturing was noted near the south end, which seemed to correlate with the separation that was found. This type of fracturing is generally related to spreading, which may mean that the edge of the slope is settling faster than the main roadway and may be due to fill settlement. An area of reeds was also found near the lower end of the fracture. These reeds, which are uncommon in this area, indicate an area of higher groundwater, perched groundwater, or a spring. Additional field work revealed the fracturing also correlated with the edge of the 1919 concrete, which explained the differential settlement of the asphalt overlay.

Figure 4 – Upper Site Diagram (S1). Not To Scale.

The movement at Site 1 correlated more closely with fill settlement at the edge of the 1919 concrete, which may have been reactivated by the 2010 resurfacing and the subsequent heavy winters of 2015 and 2017. I recommend that further monitoring of the fractures is necessary and will present a better indication of possible future movement. At Site 2, the older landslide found above the roadway, which appears to have a shallow slide plane in the tens of feet, is affecting the roadway surface and has moved at least a few inches since 2010. If this slide becomes reactivated due to increased moisture, it could damage the roadway severely. I propose that preventative measures be taken at this site to stabilize the slide mass, including dewatering of the slide mass through the use of horizontal piping draining the slide mass and buttressing the up-slope side of the roadway. If this slide increases in length headward, it may also affect the oil and gas pipelines which run above its current headscarp. Drilling to determine the actual depth of the slide plane may be necessary and can be done without damaging the integrity of the 1918-1926 roadway surfaces. Sites for drilling, if determined to be necessary, will be surveyed and assessed by a licensed geotechnical engineer. Additional soil testing will also be required to determine if any additional geotechnical work or remediation will be necessary.

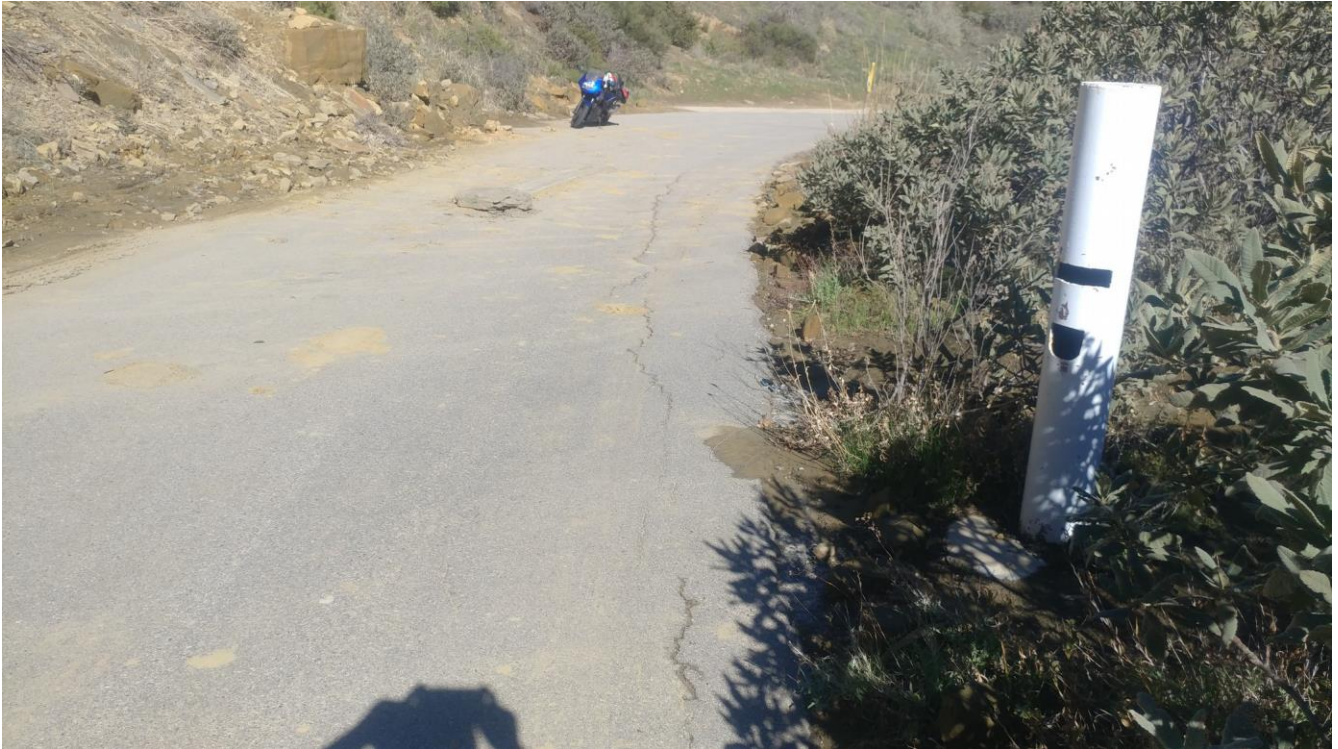
Photo 1 – Cracking at Site 1

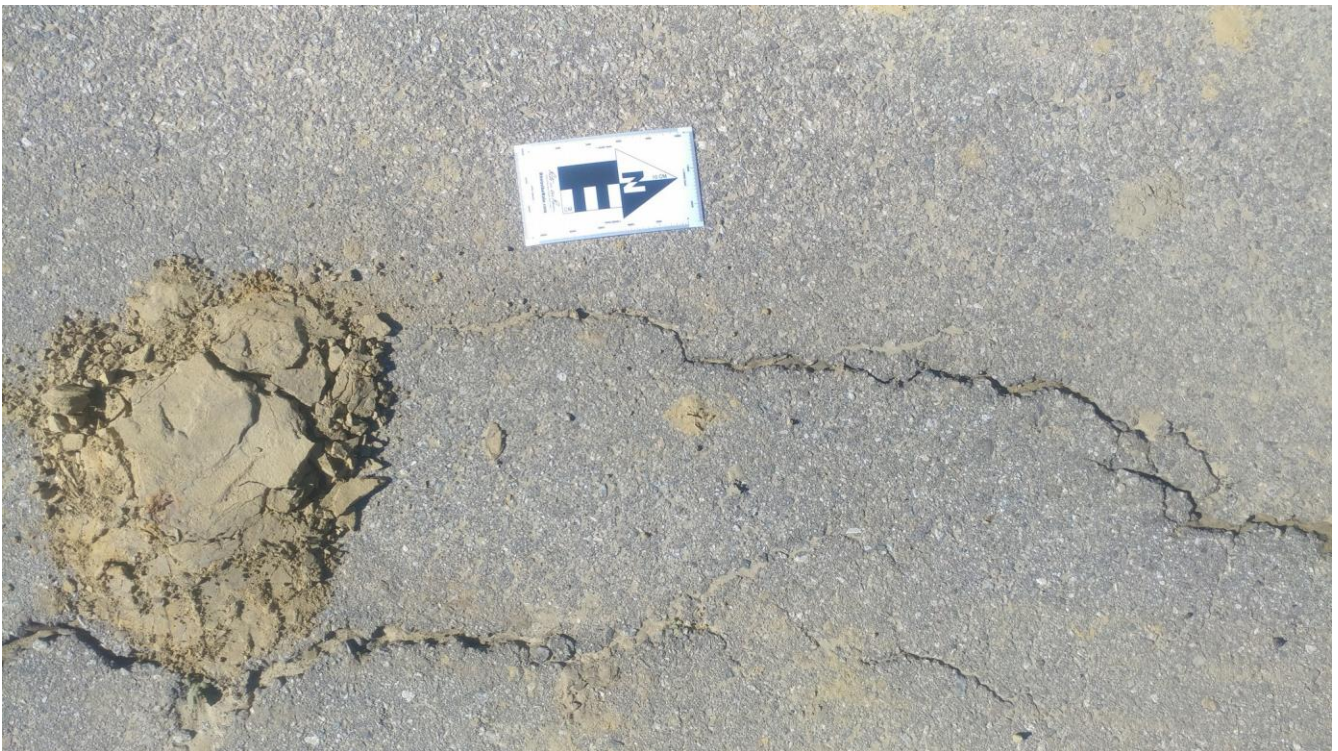
Photo 2 – En-Echelon Fracturing at Site 1

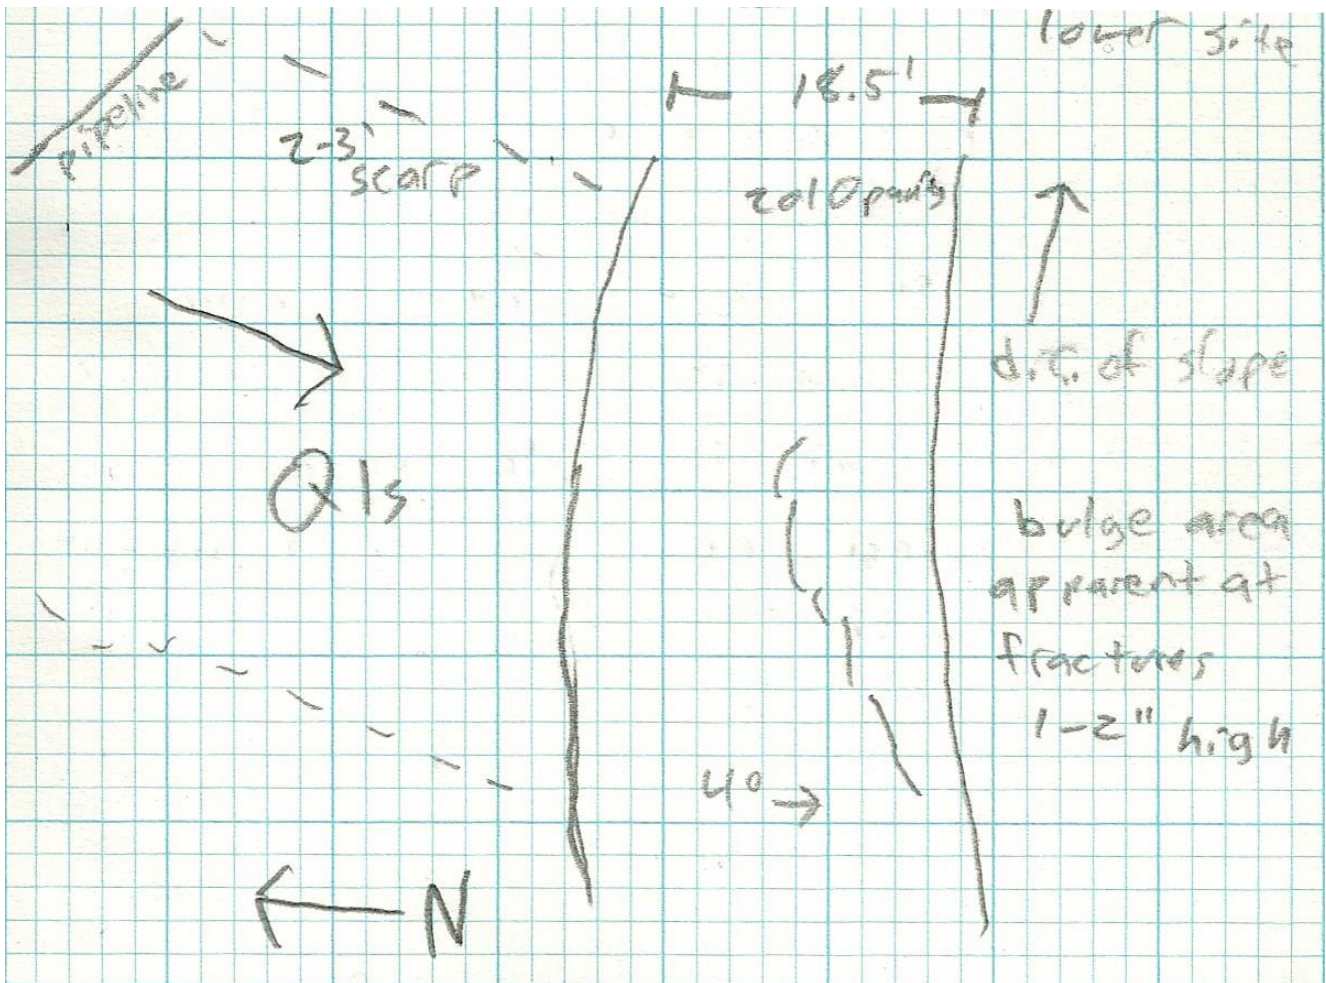
Cracking at this site was approximately 17' in length and averaged 6' from the edge of the 2010 AC overlay on the southbound side of the roadway. Cracking was closer to the edge of the roadway at the west end at about 4' and 7.5' at the east end. Some uplift, approximately 1"-2" in height relative to the surrounding pavement was observed between the cracking and the edge of the roadway. Above this site, a medium sized slump-type landslide was found, with an approximate surface area of 450 ft<sup>2</sup>. The headscarp of the slide was measured to be about 3 to 4' high. The slide area has a hummocky surface but seemed to be well-drained toward its western side. The cut slope adjacent to Site 2, which exposed some slide material did not show any signs of additional movement. The slide plane may extend below the roadway at a shallow surface, as the uplift in the roadway seems to indicate.

Figure 5 – Lower Site Diagram (S2). Not To Scale.

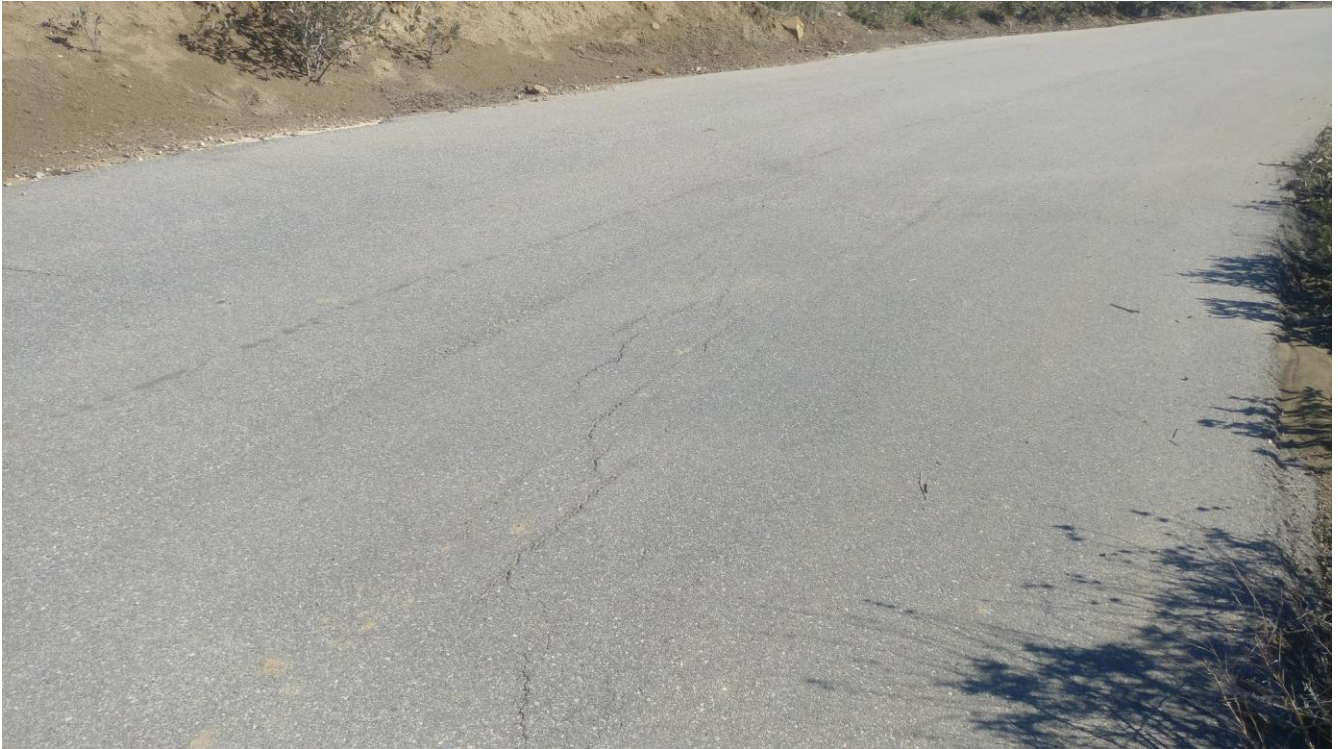
Photo 3 – Cracking at Lower Site (S2)

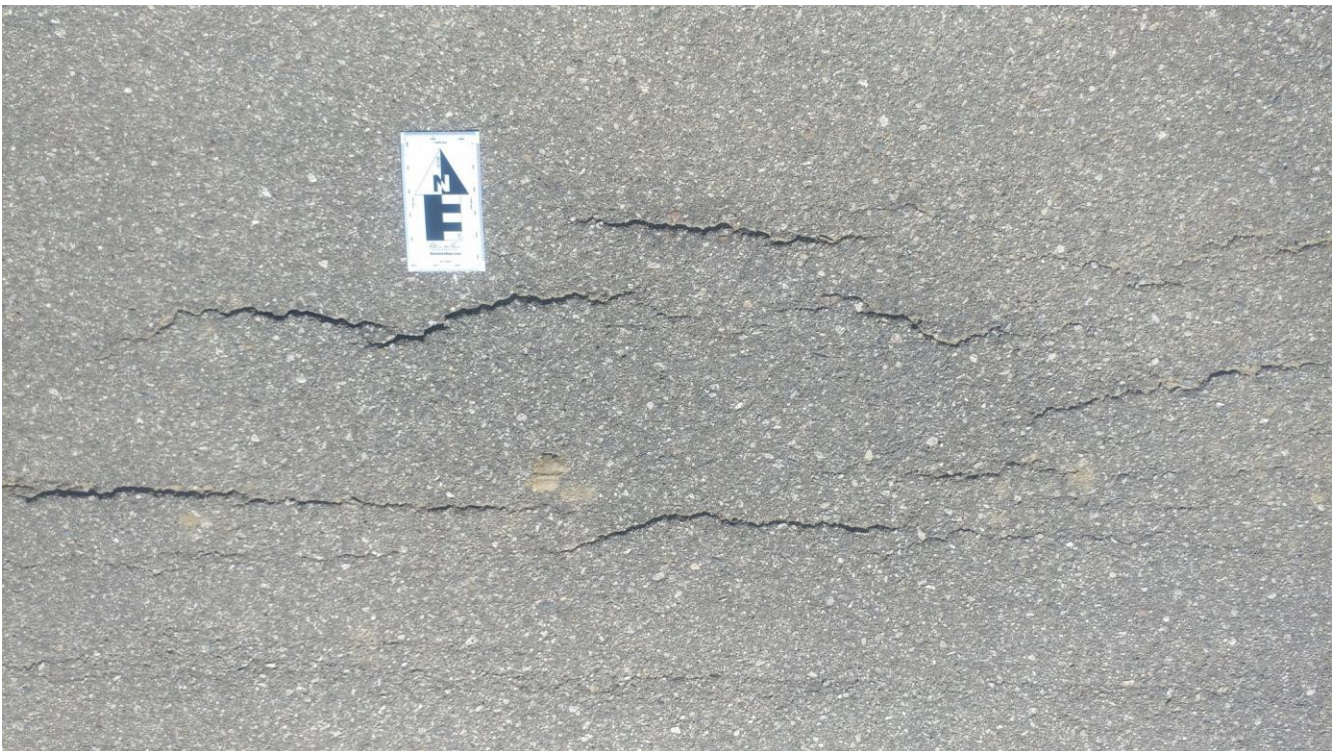
Photo 4 – Area of uplift and fracturing

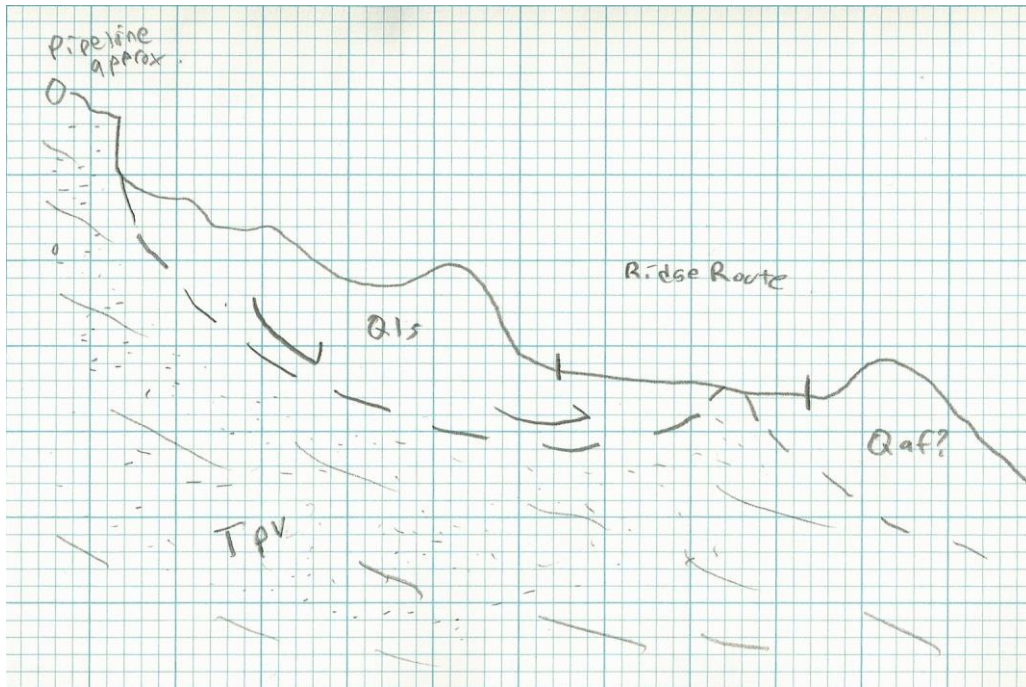
Figure 6 – Inferred Landslide Cross Section within the Peace Valley Fm (Tpv). Not To Scale.
