## Final Report

Preliminary geologic investigation of potential landslides  
in the vicinity of the southern Forest Service gate on the Ridge Route  
in northern Los Angeles County, California

Michael F. Ballard, Geologist

Prepared For  
Ridge Route Preservation Organization  
June 2019

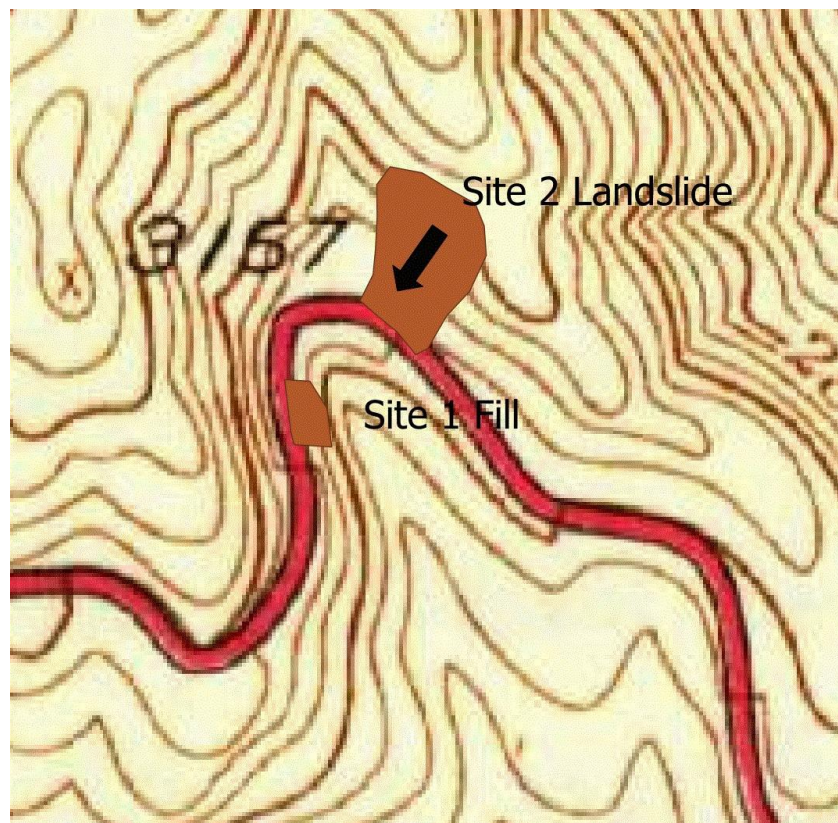
Figure 7 – Map of Study and Landslides

The movement at Site 1 correlated more closely with fill settlement at the edge of the 1919 concrete, which may have been reactivated by the 2010 resurfacing and the subsequent heavy winters of 2015 and 2017. I recommend that further monitoring of the fractures is necessary and will present a better indication of possible future movement. At Site 2, the older landslide found above the roadway, which appears to have a shallow slide plane in the tens of feet, is affecting the roadway surface and has moved at least a few inches since 2010. If this slide becomes reactivated due to increased moisture, it could damage the roadway severely. I propose that preventative measures be taken at this site to stabilize the slide mass, including dewatering of the slide mass through the use of horizontal piping draining the slide mass and buttressing the up-slope side of the roadway. If this slide increases in length headward, it may also affect the oil and gas pipelines which run above its current headscarp. Drilling to determine the actual depth of the slide plane may be necessary and can be done without damaging the integrity of the 1918-1926 roadway surfaces. Sites for drilling, if determined to be necessary, will be surveyed and assessed by a licensed geotechnical engineer. Additional soil testing will also be required to determine if any additional geotechnical work or remediation will be necessary.
